# A feasibility study of wind turbine blade surface crack detection using an optical inspection method

Huiyi Zhang<sup>1</sup>, John Jackman  
Wind Energy Manufacturing Laboratory

Dept. of Industrial and Manufacturing Systems Engineering, Iowa State University Ames, IA 50011 U.S

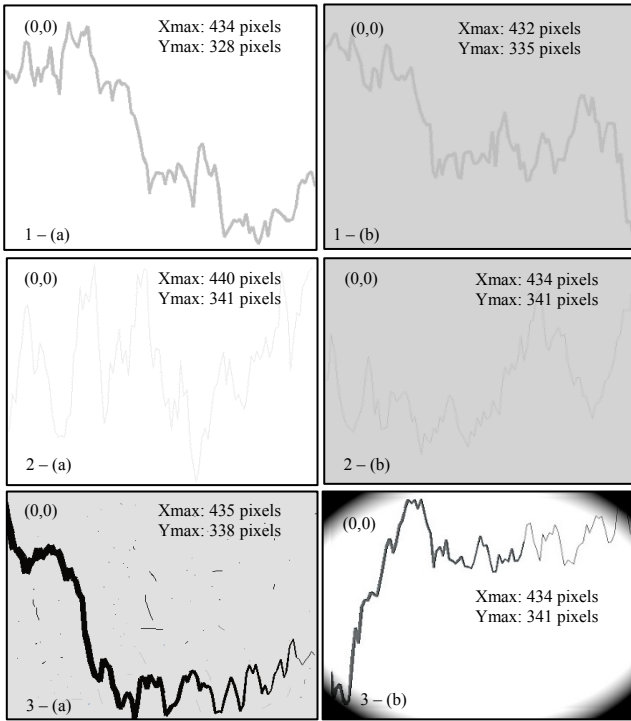
To understand detectability, a set of representative synthetic cracks was generated with one dimensional (1D) Brownian motion to create samples in a controlled fashion as shown in Fig. 2. “1D Brownian motion is composed of a sequence of normally distributed random displacements and their sum represents a particle trajectory in one dimension” [13]. The reason to use 1D Brownian, rather than 2D is that 2D Brownian has random moving particles along both x and y axes and their sums do not form a crack-like geometry. In addition, the intensity level of pixels of the synthetic crack itself was varied to represent the severity of a crack. The background color of the synthetic cracks was defined as either white or light gray to be consistent with the paint color of a rotor blade. The color of surface cracks gradually changes as the cracks go deeper into the surface and become easier to identify in digital images. The complexity of a synthetic crack was reflected in its non-uniform thickness, variation in color, and small derivative cracks.

Fig. 2. Synthetic cracks: Group 1, 2, and 3.

Difference in the intensity level of pixels, irregular distribution and geometry of noise, and uneven illumination of the image background are three major concerns that can significantly decrease the detectability of a crack [14]. Also the geometry and color of a crack may have some level of impact on the defect detectability. Therefore, we generated three representative groups of synthetic cracks as shown in Fig. 2. Synthetic cracks can better represent the random nature of

cracks because they are more flexible for manipulating the key parameters of a crack. The only difference between the synthetic cracks in group 1 is the intensity level of the pixels on the background. The second group was used to examine if computer-based optical inspection can find defects that are difficult to see with the human eye. The third group included the effect of severe noise and uneven illumination.

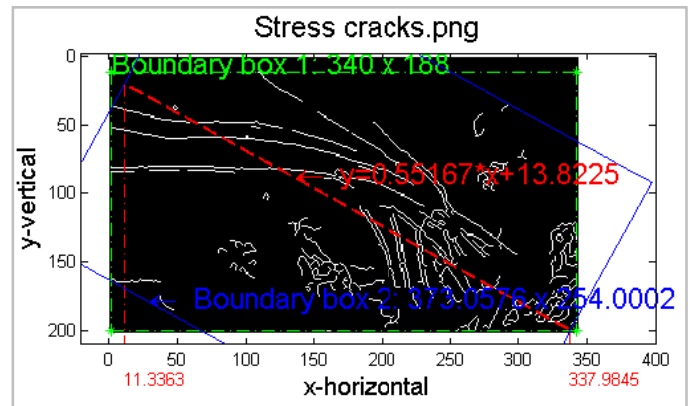
The units of the boundary boxes in Fig. 6 and 7 are in pixels which can be converted to mm if there is dimensional information associated with the image. The location of the cracks can be inferred with the whole blade images.

Fig. 6. Quantification of the field image in Fig. 3 (b): rotated 90 degree C.W. Approximation line function:  $y = 0.55x + 13.82$ . Boundary box 1: 340 x 188 pixels. Boundary box 2: 373 x 254 pixels

Uneven illumination is not a major factor in edge detection methods and noise can be significantly reduced with the optimized threshold algorithm as shown in Fig. 5. Therefore, the edge detection algorithm minimizes Type 1 error, which includes the optimized threshold algorithm (see Fig. 6, 7).

crack can be inferred from the intensity levels of the pixels along the detected edges. If an image contains severe Type 1 error, the parallel lines drawn by the defect quantification algorithm will also contain the noise as shown in Fig. 6, 7. This indirectly explained why it was important to minimize background noise.

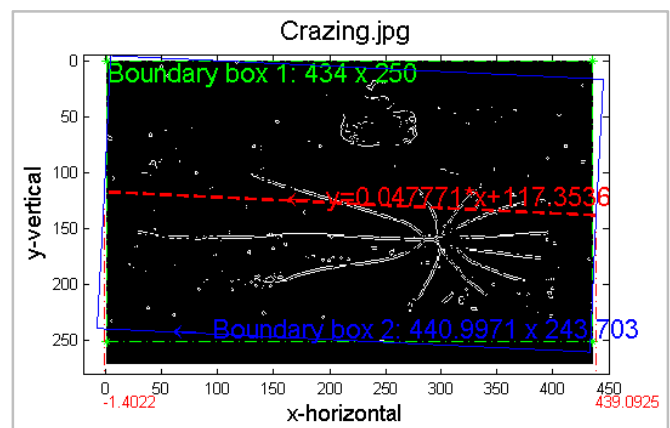
Fig. 7. Quantification of the field image in Fig. 3 (c): rotated 90 degree C.W. Approximation line function:  $y = 0.05x + 117.35$ . Boundary box 1: 434 x 250 pixels. Boundary box 2: 440 x 244 pixels

Environmental noise like dirt or insects caused problems with the accuracy of quantifying surface flaws as shown in Fig. 7, because it could not be identified and eliminated in 2-D images. Also, noise had more of an impact in images with uneven illumination, making it more difficult to eliminate noise. Further study on identifying and minimizing noises is important for the computer-based optical inspection method.
